## CONDITION ASSESSMENT OF XLPE MV CABLE JOINTS BY USING AN INSULATION TESTER

Henrik ENOKSEN  
SINTEF Energy Research - Norway  
henrik.enoksen@sintef.no

Ole Johan HATLEN  
BKK - Norway  
ole-johan.hatlen@bkk.no

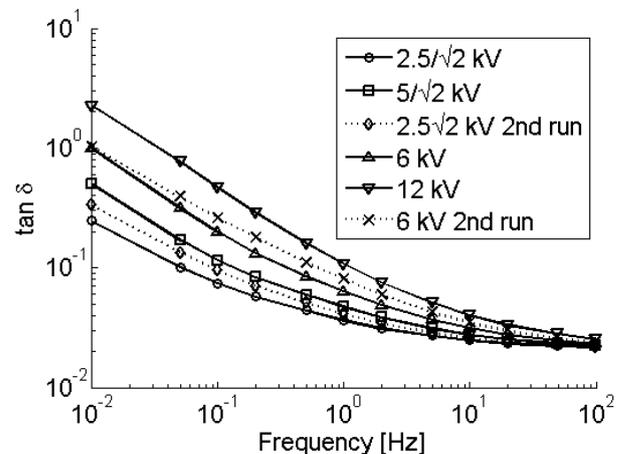
The great increase in the loss tangents at low frequencies indicates that the conductivity of the joint is large, see Eq. (3). This is most likely caused by high water content in the joint [4]. One possible reason for obtaining much higher loss tangents in the laboratory than in service, even after correcting for the cable length, could be presence of condensed water at interfaces in the joint. In any case, these results strongly indicate that the joint is the cause of the high loss tangents measured in service. Hence, there is no indication of severe water tree degrading in the cable.

The dotted lines of Figure 3 show the second measurements of  $2.5/\sqrt{2}$  kV and 6 kV performed after  $5/\sqrt{2}$  kV and 12 kV, respectively. These results indicate slight hysteresis in the loss tangent. In the case of bridging water trees, the hysteresis should be significantly larger [3].

**Figure 3: Loss tangent as a function of frequency for different voltages for phase L2 measured in the lab.**

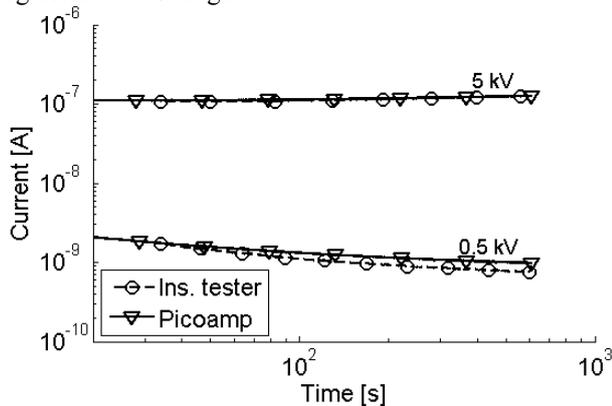
Figure 4 and Figure 5 show the polarization and depolarization currents, respectively, for phase L1 at 500 V and 5 kV measured with the insulation tester and the laboratory setup. Results for voltages 1 kV and 2.5 kV, and the other two phases are not shown, though the measurements at these voltages show similar magnitudes. As instrumental current transients from the insulation tester disturb the measurements during the first 30 seconds, these are omitted. It is observed that the difference between the currents measured by the two setups is very small and can for practical purposes be neglected in this range.

Figure 4: Polarization currents measured with a picoamperemeter (solid lines with downwards triangles) and the insulation tester (dashed lines with circles) for phase L1 at 0.5 kV and 5 kV.

According to theory, the polarization current should relax to a steady conductive current after the polarization processes are diminished, see Eq. (1). The measured polarization current magnitudes are however very large compared to the depolarization currents even after short times and low voltages. This indicates a large contribution from the conductivity of the joint. The origin of the low resistance (high conductivity) could be increased moisture content of the joints [4]. Another

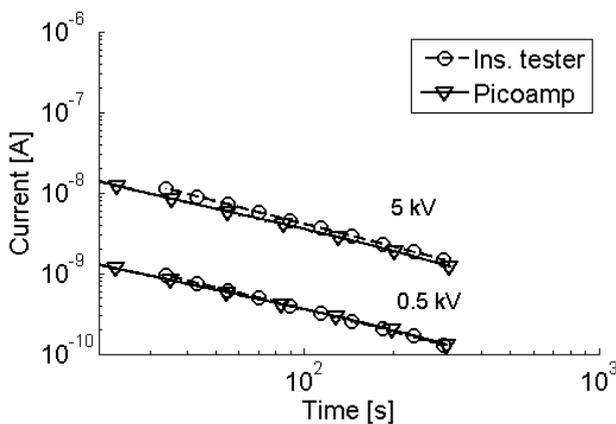
Figure 5: Depolarization currents measured with a picoamperemeter (solid lines with downwards triangles) and the insulation tester (dashed lines with circles) for phase L1 at 0.5 kV and 5 kV.

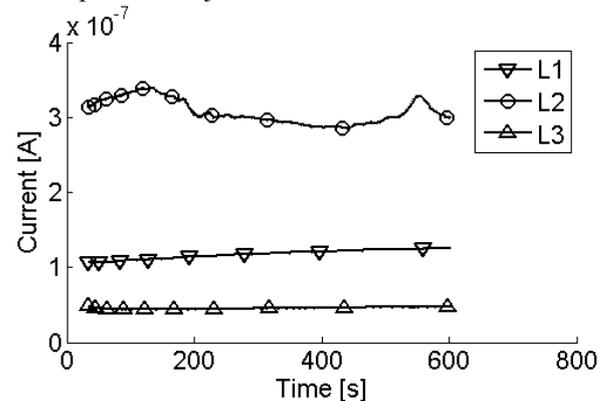
reason can be an increase in the conductivity induced by overheating causing material oxidation. Moreover, the currents at 5 kV display an unstable oscillatory behavior for L2, and for L1 and L3 the currents increase with time as shown in Figure 6. This may be caused by movement of condensed water located at the interfaces between the different parts of the joint.

Figure 6: Polarization currents measured with the insulation tester for all phases at 5 kV shown at a linear scale.

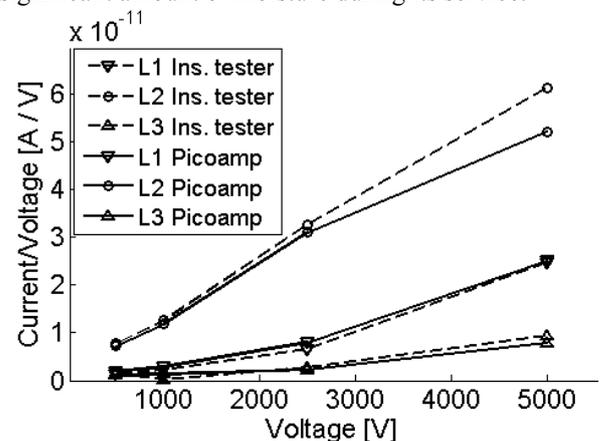
Figure 7 shows that the polarization currents have a significant voltage dependence. It has previously been shown that high water content in the joint materials will make the conductivity voltage dependent [4] as indicated in Figure 4. Hence, it is likely that this joint has absorbed a significant amount of moisture during its service.

Figure 7: Polarization currents as a function of applied voltage for all three phases (L1 downwards triangles, L2 circles, and L3 upwards triangles). The currents are normalized with respect to the applied voltage and each data point is the average value of the data taken from the last two minutes of measuring. The dashed and solid lines denote insulation tester and picoamperemeter, respectively.

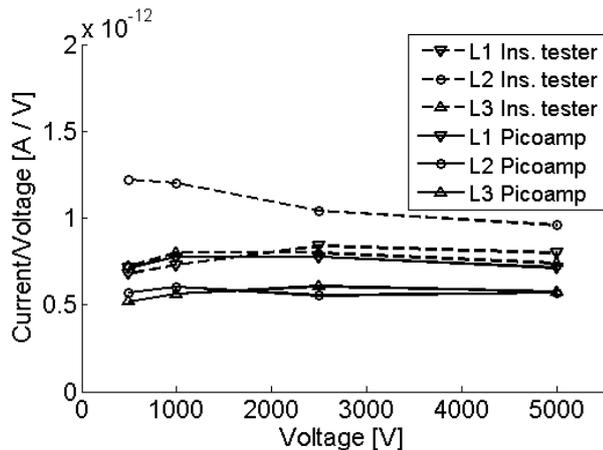
Figure 8 shows that the depolarization current is much less dependent on voltage than the polarization current. If a high number of long vented water trees were present, the depolarization current would likely be voltage dependent [5].

**Figure 8:** Depolarization currents after 100 seconds as a function of applied voltage for all three phases (L1 downwards triangles, L2 circles, and L3 upwards triangles). The currents are normalized with respect to the applied voltage. The dashed and solid lines denote insulation tester and picoamperemeter, respectively.

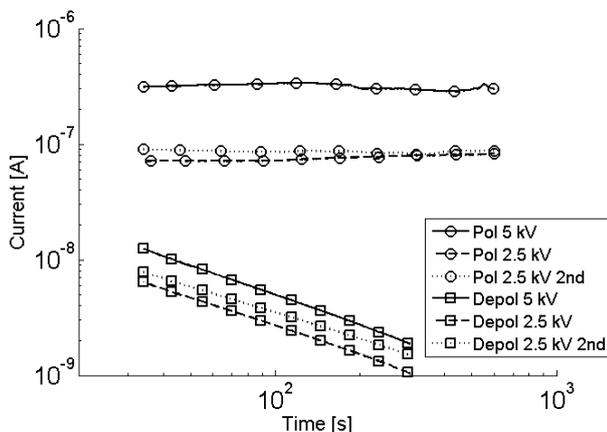
The initial measurements of the loss tangent indicated that the cable was heavily water-treed due to the high values shown in Table 2. Figure 9 shows the polarization and depolarization currents measured at 2.5 kV, then 5 kV, and then at 2.5 kV again for phase L2. The other phases show the same behavior. Note that only 0.5 m of the cable on each side of the joint is included in these measurements. Still, if the cable had been severely water tree degraded, this cable length should have contained enough water trees to yield a significant hysteretic effect as expected from heavily water tree degraded cables [3]. However, only a slight hysteresis is observed. This corresponds to the slight hysteresis observed in Figure 3. Hence, the cable is probably not severely water tree degraded. It is more likely that the low resistance joints are the cause of the large loss tangents, rather than water trees bridging the insulation.

**Figure 9:** Polarization and depolarization currents for phase L2 at 2.5 kV first run, 5 kV, and 2.5 kV second run, denoted by dashed, solid, and dotted lines, respectively. Polarization and depolarization currents are denoted by circles and squares, respectively.
