## DEALING WITH IN-FIELD REPAIR TASKS OF LARGE POWER TRANSFORMERS

José Luis MARTINEZ  
Edenor - Argentina  
jmartinez@edenor.com

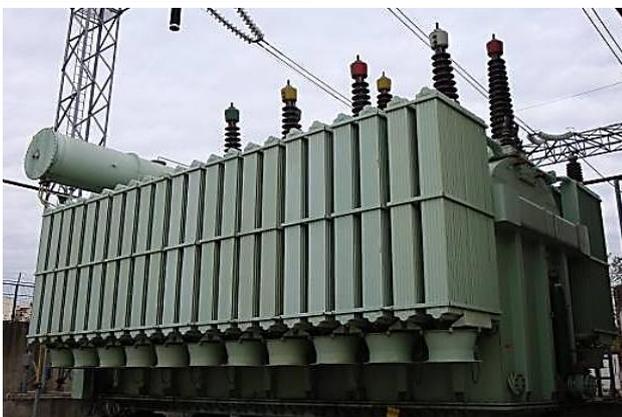
As a consequence of an internal discharge in a bushing of a 220/132kV, 300MVA power transformer, its outage was produced. Such event caused a number of damages of magnitude on the unit, including destruction of several 220 and 132 bushings, affectation of internal CTs and accessories and deformation of main and auxiliary tanks, seriously damaging the transformer condition as a whole. At the time of the event, the company did not have a similar spare unit.

Fig. 2 - 300.000 kVA, 3-phase power transformer  
3-phase power transformer, core type (Fig. 2)

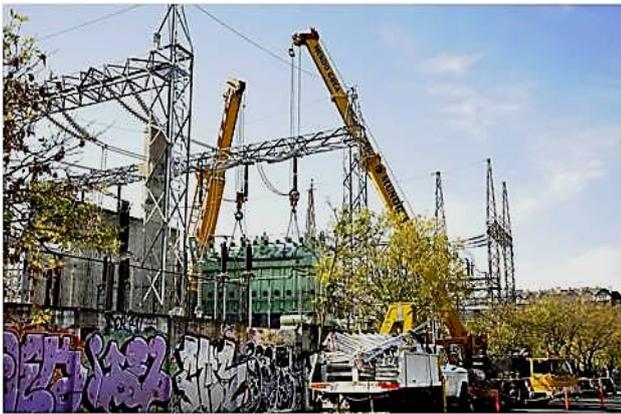
Fig. 3 - Lifting the 300.000 kVA, 3-phase power transformer

Facing the repair required the displacement of the unit from its emplacement to a free area nearby, to make the lifting of the bell possible by means of suitable cranes and finally, un-tanking the active part (Fig. 3).

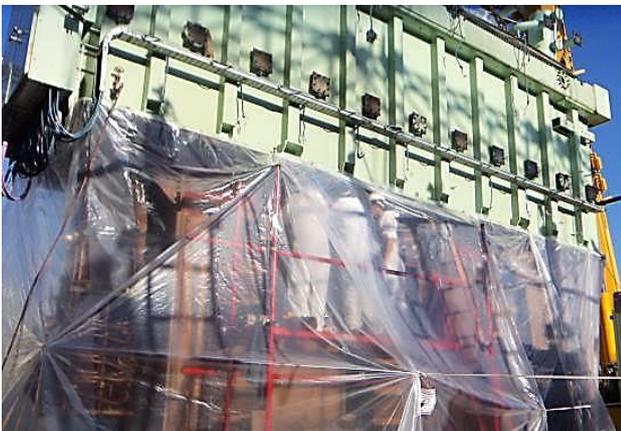
Once the bell was lifted and the active part completely exposed, it could be verified that the damages produced were neither, higher nor different than the expected through the measuring and the internal inspection previously executed, confirming so, the feasibility of performing an in-field repair (Fig. 4).

Fig. 4 - Execution of tasks under controlled conditions  
The planned tasks included the following steps:

- Cleaning away residues, rests of carbon and burnt paper product of the discharge and pieces of broken porcelain, spread all around the affected column.
- General repairs, replacement of damaged insulating barriers and broken clamping pieces, re-insulating of leads, re-clamping of windings, etc.
- Drying out of windings by hot oil spray.
- Displacement to the base and final assembly.
- Electrical verifications.

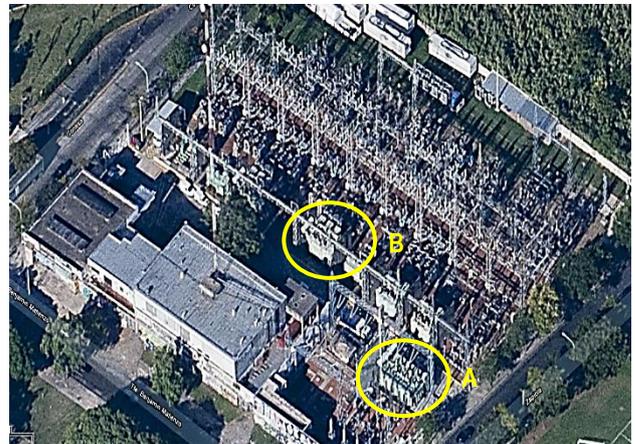
Fig. 5 - Aerial view of the station. "A" transformer under test and "B" feeder transformer for the overvoltage test.

From this limitation, it was decided to utilize the own structure of the transformer station to feed the unit to be tested by means of a 132/13,8kV, 40 MVA power transformer belonging to the station fleet. This required using one of the 132kV bus-bars of the station as part of

Such issue imposed re-configuring the HV bus-bars system in a particular way, so as to reach the circuit, technical and safety characteristics required, *what represented a highlight of the repair executed* (Fig. 5).

Since the transformer under test was a relatively aging unit, a voltage level 5% higher than the rated voltage was applied, in order not to over-stress its insulation system, extending its duration for 1 hour. So, the 132kV winding was energized from the HV/MV feeder transformer and voltage regulation was performed from its OLTC.
