ANALYSIS OF RUSTY CLOSED TYPE SWITCHGEARS

Kazuki MORII

The Kansai Electric Power Co., Inc. - Japan

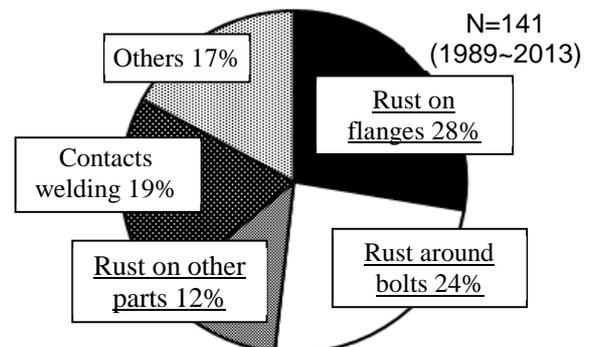
Fig.3: Broken Points on SWs

We visually inspect all of each distribution facility every five years. In the case heavily damaged SWs are found, we replace and investigate some of them in details. Based on past investigation result, we have analyzed the causes of SWs deterioration. Fig.3 shows the broken points of SWs. Rusty SWs accounts for 64%, therefore, we focus on rust and investigate the progress of degradation.

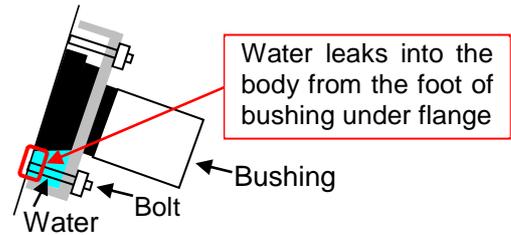
Fig.7: Water Leaking at Flange

Rust on flanges covering bushings have been observed most frequently on rusty SWs. Because SWs had been exposed to rain and wind including sea breeze, the salt content had remained at the flanges; this rusted them, and affected SWs' airtightness. (Fig.6, 7)

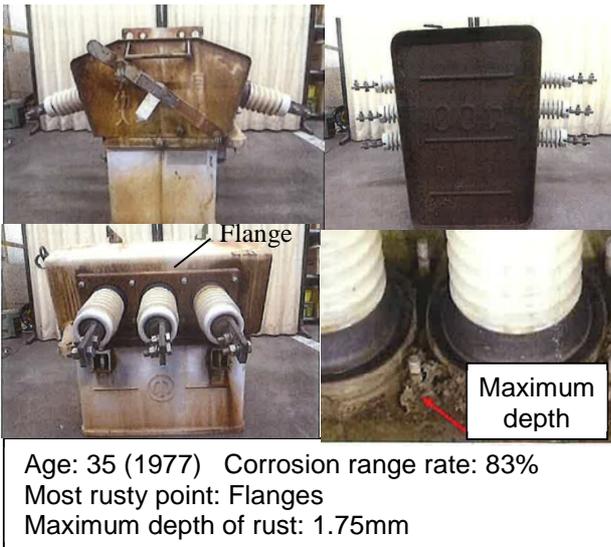
Fig.4: an Example of Totally Rusty SW

Fig.4 and Fig.5 show two SWs to compare rust condition, one is totally rusty, and the other is partially rusty. Each corrosion range are different, but both SWs have severe rust on flange parts. Flange around bushings is the rustiest point on SWs; significant thinning and holes are confirmed on them.

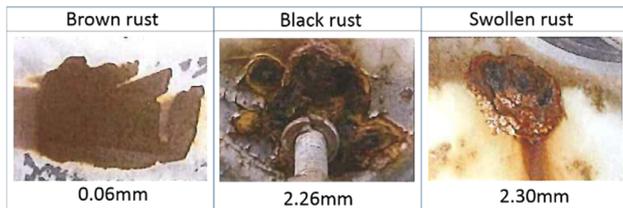
Fig.10: Aspects of Rust and Depth

We examined relevance between the depth of corrosion and outlook of rust such as area and color. Black rust is much worse than brown rust. In addition, swollen rust is confirmed as bad as black rust, corrosion by swollen rust reaches almost as same depth as black rust. (Fig.9, 10)

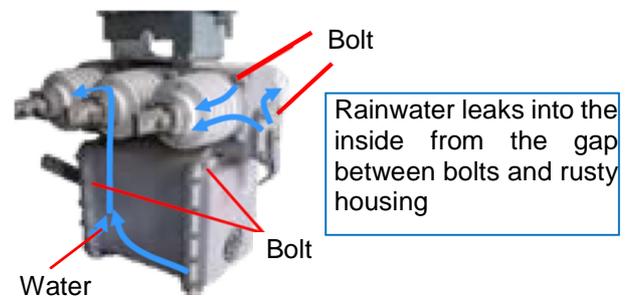
Fig.13: SW with Aluminum Housing

As mentioned above, some SWs have aluminum housing because aluminum is more resistant to rust than iron. However, stainless steel bolts are used for this type of SW; Dissimilar metal corrosion have occurred between stainless and aluminum due to ionization tendency difference.

Dissimilar metal corrosion occurs between the stainless steel bolt and the aluminum housing, therefore corrosion of the aluminum housing is promoted; this causes the damage on airtightness.

Then rainwater leaks into the inside of SW through this gap. This leads to the dielectric breakdown at bushing.

Accordingly, we have reflected this knowledge in our new specification of SW; the stainless steel housing and stainless steel bolts are adopted in the current type SW.
