SENSITIVITY ANALYSIS OF CABLE OSCILLATING WAVE TEST SYSTEM ON MULTI-SOURCE DEFECTS DIAGNOSTICS

Guojun LU
Guangzhou Power supply
Bureau
lugj@guangzhou.csg.cn

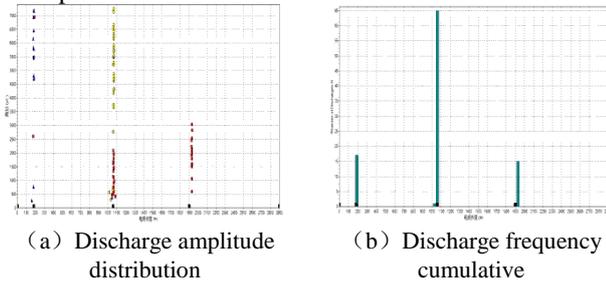
Fig.2 the Results of Partial Discharge Detection and Locations

The relative positions of the concentrated discharge were showed as the figures below. Abscissa represents the length of the cable, ordinate represents the discharge pulse amplitude distribution and discharge frequency accumulation for tests under different oscillating voltage. Red, yellow, and blue, respectively, on behalf of A, B, C

Statistical analysis the three-phase starting discharge characteristics of No. 1, No.2, No.3 joints, the results show that: No.1 middle joint discharge phase C existed concentration discharge, initial discharge voltage is 13 kV (1.5 U_0 , U_0 for rated voltage 8.7 kV), the amplitude distribution ranges from 4600 pC to 7000 pC. No.2 middle joint discharge phase A and B existed concentration discharge. Initial discharge voltage for phase A is 6.2 kV (0.7 U_0), the amplitude distribution ranges from 800 pC to 2000 pC. Initial discharge voltage for phase B is 8.7 kV (1.0 U_0), the amplitude distribution ranges from 2700pC to 7250pC. Phase C existed accidental discharge, low frequency, happened in 1.7 U_0 , amplitude is less than 500 pC. No.3 middle joint discharge phase A existed concentration discharge. Initial discharge voltage for phase A is 8.7 kV (1.0 U_0), the amplitude distribution ranges from 1000 pC to 3000 pC .

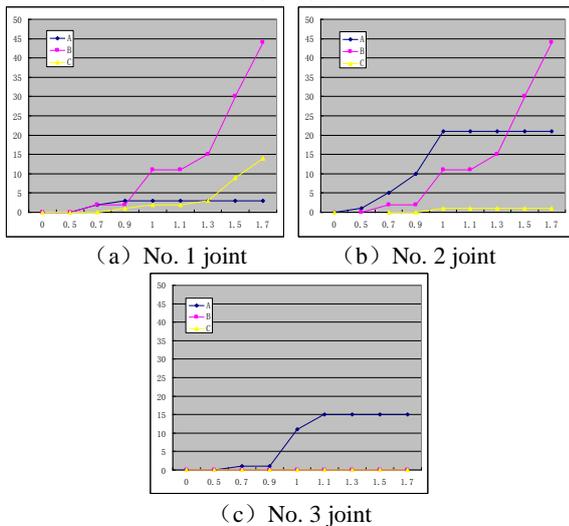
Fig.3 the Relationship between Partial Discharge and Test voltages

Figure 3 shows the statistical analysis of the relationship between three middle joints ' discharge frequency characteristics and test voltage. Abscissa is applied voltage ratio (U_0), while ordinate is pulse accumulation number. The result shows that discharge pulse accumulation number increased with the increase of applied voltage, had a stepped up trend, and matched the typical discharge characteristics. The three-phase

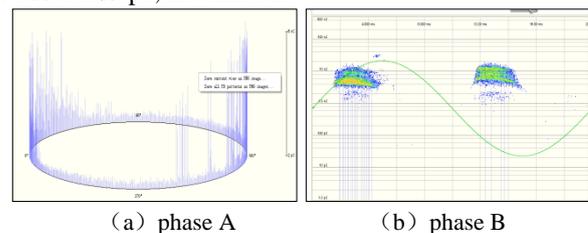
Fig.5 the Amplitude of the Discharge under different test voltages

We re-identified the phase for three phases of No. 2 defective joint after installing terminal. Based on the process of national standard, applied a test voltage 1.73 U_0 , the apparent discharge respectively: Phase A more than 8 npC, frequent; Phase B more than 5npC, phase C is about 105 pc, intermittent.

By using ladder booster method (voltage from zero, in turn keep 5 mins in 0.5 U₀, U₀, 1.2 U₀, 1.5 U₀, 1.73 U₀ for partial discharge measure), tracking the relationship between discharge amplitude and the test voltage, as shown in figure 6 below. Ordinate is discharge value(pC), while abscissa is the multiples (U₀) of test voltage.

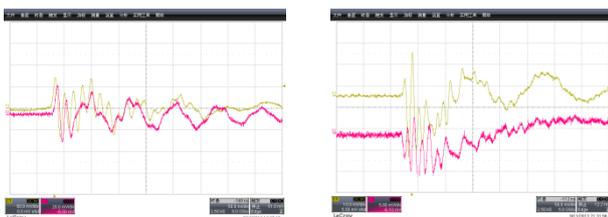
Fig.8 Simulated and Measured Results

The result of the partial discharge diagnosis test shows that the discharge signals detected had reverse polarity and repetition characteristics, which proved that signals

were from No.2 defective joint, excluding the introduction of discharge defects due to the new joint.

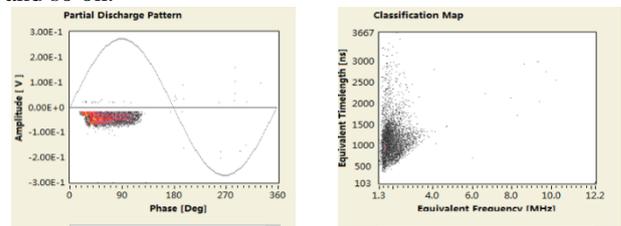
Fig.9 A Phase PRPD Map under 1.73U₀

Results shows that: when phase A was applied U₀, pattern recognition reflected two types signals, surface discharge and, internal discharge. When voltage raised to 1.73U₀, surface discharge disappeared, left internal discharge only. For phase B, there were surface discharge and internal discharge from beginning to end. Signals of phase C were weak and intermittent, and the discharge has 180 °phase characteristics, but cannot be recognized for lack of data.

According to the experiment result above, when phase A was applied U₀, pattern recognition reflected two types signals, surface discharge and, internal discharge. When voltage raised to 1.73U₀, surface discharge disappeared, left internal discharge only. Disintegrated checking exposes the causes. For one thing, the cold tube surface not fully contact with the main insulation surface due to scratches on surface of the main insulation. When silicon grease dry or daub is inadequate, it would formed an air gap in the Insulation composite material interface, and thus lead to Internal discharge. For the other thing, lap joint between cold pipe and semi-conducting layer was excessive, making the electric field concentrated at the semi-conducting layer, and thus lead to Internal discharge under the oscillating voltage. When the test voltages rise gradually, discharge defects disappear gradually, because the partial discharge charge short-term accumulation eased the local concentration of the electric field. Additionally, insulation distance of the main insulation surface was not too short, increasing the electric strength

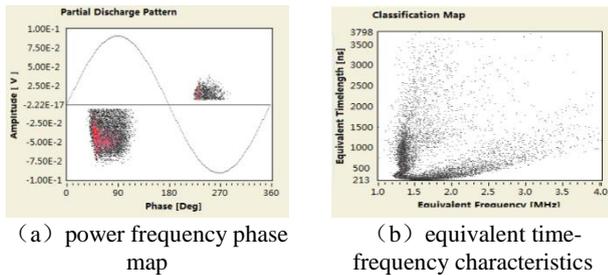
Fig.10 B Phase PRPD Map under 1.03U₀

For phase B, there were surface discharge and internal discharge from beginning to end. For one thing, the cold tube surface not fully contact with the main insulation surface due to too much lapping of semi-conducting electrical tape, forming an air gap in the Insulation composite material interface, and thus lead to Internal discharge. For the other thing, lap joint between cold pipe and semi-conducting layer was excessive, making the electric field concentrated at the semi-conducting layer, and thus lead to Internal discharge under the oscillating voltage.

With the raise of test voltage, phase B present the different discharge trend with phase A, and the main insulation surface discharge type persisted. Because insulation distance of phase B is more insufficient and the air gap discharge and surface discharge in the same side, making the insufficient of electric strength for discharge defect, and thus the discharge persisted with the increase of test voltage.

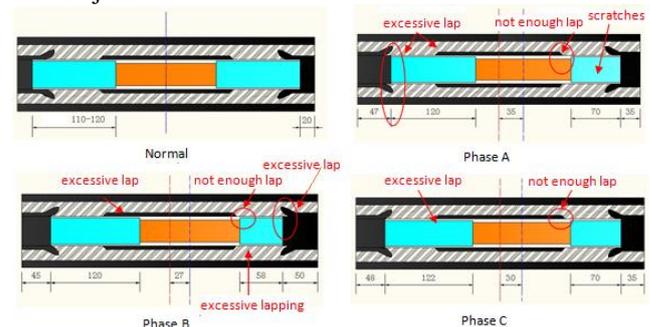
Fig.11 the Relative Size of the Intermediate Joint

1) Surface of the three phase pressing duct did not grind, and had burrs, with Semi conductive tape on it (technology does not demand). Phase B had too much semi conductive tape winding on it, causing not enough contact with the main insulation surface, and thus leaving air gap.

2) Semi-conducting layer between shrink tubing and the main insulation surface did not match the demand, existing taking surplus phenomenon. For phase A, lap between shrink tubing and the main insulation surface were respectively 47mm,35mm. For phase B, lap between shrink tubing and the main insulation surface were respectively 45mm,50mm. For phase C, lap between shrink tubing and the main insulation surface were respectively 48mm,35mm. The technological requirements of lap is 20mm.

3) The lap between semi-conducting layer of the shrink tubing and pressing duct did not satisfied the technological requirement, existing cooperate with dislocation phenomenon. One side of phase A was less fit about 10mm, the other side was interference fit about 50mm. One side of phase B was less fit about 7mm, the other side was interference fit about 46mm. One side of phase C was less fit about 10mm, the other side was interference fit about 49mm.

4) Obvious scratch, with the length of 70mm, was found on the main insulation surface of Phase A.

5) The insulation distance of the main insulation surface was not enough. For example, in disintegrated checking of phase A, although the main insulation surface length of one side satisfied the demand, effective insulation distance is only 70 mm due to stress cone interference, which was inadequate. The insulation distance of the main insulation surface of one side was 73mm, also inadequate. For phase B, although the main insulation surface length of one side satisfied the demand, effective insulation distance is only 73 mm due to stress cone interference, which was inadequate. The insulation distance of the main insulation surface of one side was 58mm, also inadequate. For phase C, the main insulation

surface of one side meet the demand basically, while the insulation distance of the other side was only 70mm, inadequate. Technical requirements: generally range from 110 mm to 120 mm.

To reflect the construction process problems found in disintegrated checking more intuitively, we recovered the three-phase actual size measured of No.2 defective middle joint.
