## EVALUATION OF AGING DEGRADATION OF 6KV CV CABLE (THREE-LAYER CO-EXTRUDED STRUCTURE)

### ABSTRACT

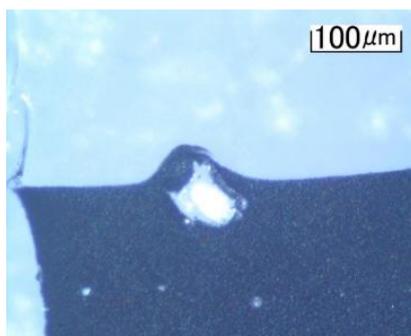
<Picture of origin of water tree>

The specific cables judged as defective were studied by magnification observation and elemental (EDX) analysis. As a result of magnification observation, as shown in Figure 2, it was confirmed that a water tree originating from the outer semiconductive layer interface of insulator was generated. In addition, there was micro projections in the outer semiconductive layer at the original point of the water tree, and white cohesion solid existed inside the projection. From EDX analysis of this cohesion solid, it was investigated that the solid was magnesium oxide used as a compounding agent. These features were confirmed in all cables examined, although there were some differences.

- Cable 6.6kV 150mm<sup>2</sup>
- Size of a projection 40×180µm
- Length of water tree 2730µm

Since newly purchased E-E cable has changed their semiconductive layer to material without cohesion solid as described above, there is no problem concerning newly installed ones. Meanwhile, the all Specific cables installed at the field are planned to be replace by 2023 as same countermeasures to the T-T cables and E-T cables.

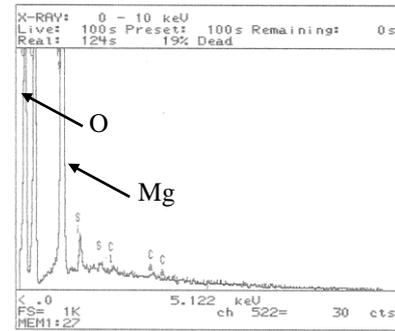
<Picture of a projection cross section >

Consequently, it was confirmed that water trees occur and extend by diffusion of magnesium cation into insulator. This happens only when the cable had a projection with a height of 40 $\mu$ m or more at the insulator interface with cohesion solids of magnesium oxide as its core in the outer semiconductive layer, and also when the cable was used in moisture environment.

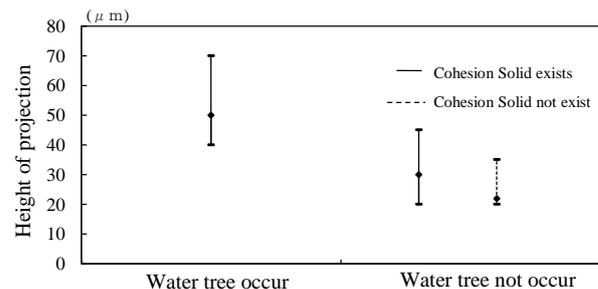
**Figure 3. Projection height and water tree occurrence**

Furthermore, in order to investigate the relation between the water tree and the micro projection, total 7,700 pieces of 0.5 mm thickness slice were taken from the defective cable. Thus the height of the projections, the existence of cohesion solids and water tree were observed for projections with a height of 20µm or more. As shown in Figure 3, water trees occurred only when the projection height was 40µm or more with existence of cohesion solids. Water tree did not occur in other cases.

It is noteworthy that water trees occurred even with a 40µm height projection, and existence of cohesion solids. Regarding the size of the projection, the height of the projection is regulated to 250µm or less according to Japanese Electrotechnical Committee JEC-208 (High voltage test method of cross-linked polyethylene cable of extra high voltage (11 to 77 kV) (1980)), and the size of 40µm is not especially large projection.

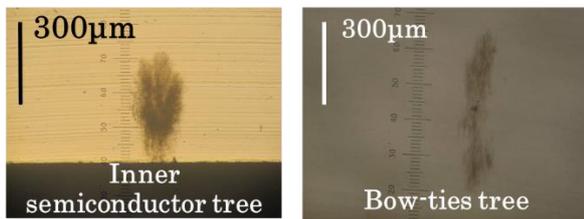
**Figure 5. Picture of each water tree**

Examples of the confirmed water tree is shown in Figure 5. Inner semiconductor tree and the bow-tie tree occurred, though we could not confirm the outer semiconductor tree. The inner semiconductor trees were confirmed with 7 samples. In addition, the bow-tie trees were confirmed in all samples (see Table 5)

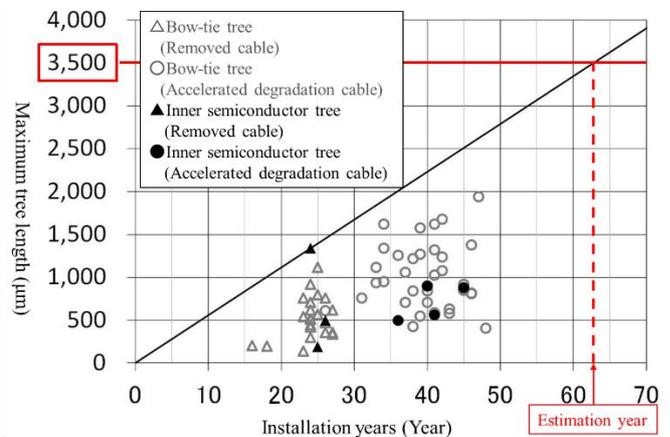
**Figure 6. Relationship between installation years and maximum water tree length**

The length of the each water tree, inner semiconductor tree and bow-tie tree which confirmed by above observation were measured. Figure 6 shows the relationship between each tree length and the installation year. The length of inner semiconductor tree and bow-tie tree tends to extend by aging. The extension characteristics of the inner semiconductor tree and the bow-tie tree are assumed to be different [5]. However, it was not possible to confirm clear differences in the respective extension characteristics.

Furthermore, a sample which is bridging the insulating layer was not confirmed, the maximum tree length from the removed cables was 1,340µm (24 years; Inner semiconductor tree), the maximum tree length from the accelerated deterioration cables was 1,940µm (47 years; Bow-tie tree). Assuming that the extension characteristic of the water tree length is linear with the time it was installed, the maximum extension speed of all samples is 55.8µm / year. Thus, assuming that the lifetime is the time when the insulating layer (thickness: 3.5 mm) bridges, the insulation lifetime is 63 years.

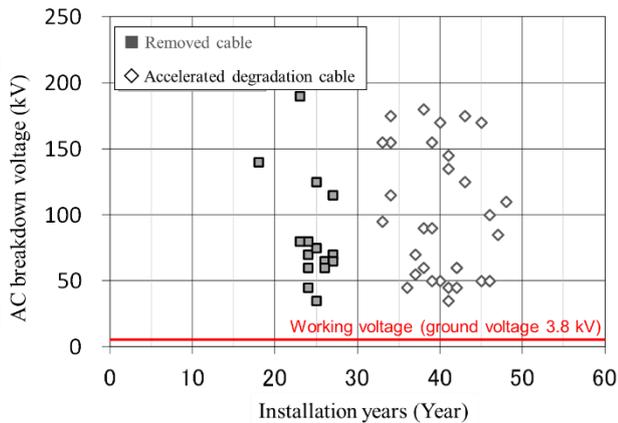
**Figure 7. Relationship between installation year and AC breakdown voltage**

Figure 7 shows the aging characteristics of the AC breakdown voltage. The result varied much and it was impossible to confirm the influence of aging only with this test result. It is considered that the reasons for the variation are that the influence of the existence of micro contamination substances in the insulating layer which is much lower than the manufacture control value, projections at the interface between the semiconductive layer and the insulating layer, the temperature and humidity of the installation location and submerged status etc. The minimum value of AC breakdown voltage was 35 kV (25 years of removed cable, 41 years of accelerated deterioration cable), which was sufficiently large compared with the working voltage (ground voltage 3.8 kV).
