USING NEW TECHNOLOGY AND ASSESSMENT METHODS TO A RELIABLE MAINTENANCE STRATEGY OF MV CABLES

Miguel MARQUES
EDP Distribuição – Portugal
migueljorge.marques@edp.pt

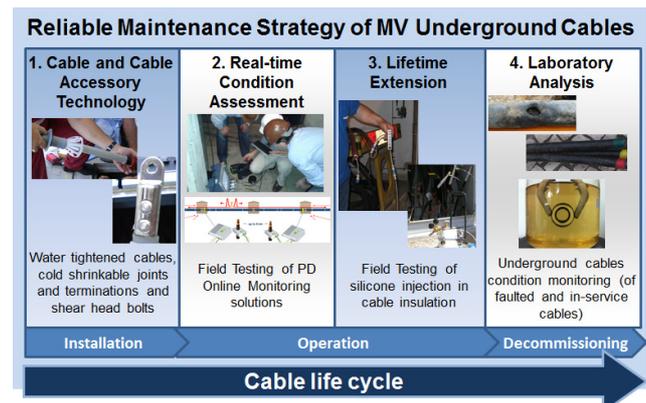
In accordance with the conclusions yielded from the cited workshops, EDP Distribuição has launched several initiatives, as pilot projects and also as definitive improvements to the underground grid components. The solutions we have tested over the past 6 years can then be divided into four categories, according to the phase of the life-cycle to which they were applied, as the diagram in Figure 1 suggests.

Figure 1 – EDP Distribuição's approach to the MV underground cables' life cycle.

The initiatives carried concern **Cable and Cable Accessory Technology**, **Real-Time Condition Assessment**, **Lifetime Extension** and **Laboratory Analysis**, all of which are detailed hereinafter.

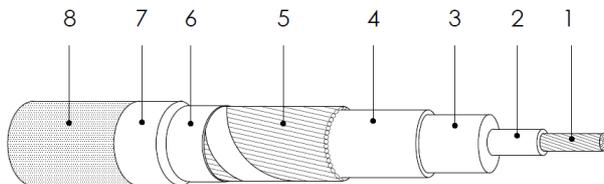
- Water-swelling tape over the copper sheath;
- Outer sheath in polyolefine (PO) material.

The goal of the changes introduced is to prevent absorption and penetration of water (guaranteed by the PO sheath) and circulation of water inside the cable (assured by the water-swelling tape) and therefore significantly reduce premature ageing caused by water treeing. Figure 2 shows this LXHIOZ1(be) cable, where the layers, numbered radially from 1 to 8, are as follows: 1)-Conductor; 2-Conductor screen; 3-XLPE insulation; 4-Insulation screen; 5-Metallic screen; 6-Longitudinal water tightness tape; 7-Outer sheath; 8- Semiconducting cover.

Figure 2 – LXHIOZ1(be) cable

As a response to this problem, EDP Distribuição had already started (back in 2008) to study, specify and redefine the standards for new cables to install in the Portuguese grid. As a result of these efforts, in 2010 a new generation of XLPE cables (called LXHIOZ1(be) according to the Portuguese Norm NP665) was introduced in the medium voltage grid. This cable differs from its predecessor in two very important constructing aspects:

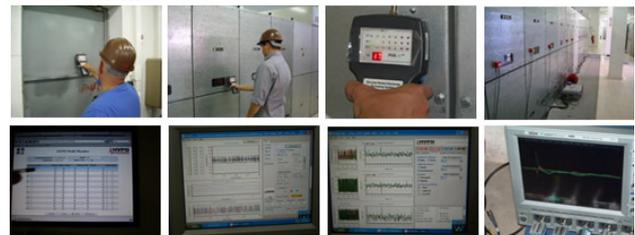
These three phases were performed consecutively and, in the last phase, the monitors were left for a period of time (2 to 3 weeks) on a location, after which the results were analysed and the equipment was moved to a different location. Using this method, we were able to monitor three primary substations. Figure 3 shows a few images of the On-line tests.

Figure 3 – Overview of the On-Line PD Tests (HVPD and DNV GL).

The **SCG ® (Smart Cable Guard)** is the **DNV GL** solution, and it presents a very wide experience and a proven track record in several utilities around the world. Each SCG ® system consists of two measurement units, one at each end of the assessed cable, in either a substation or a RMU (Ring Main Unit). Each of these measurement units includes a Sensor/Injector Unit (SCG - SIU) and a Controller Unit (SCG - CU). The SIU contains a sensor to measure pulses from the cable and an injection device to inject pulses into the cable [2]. The CU controls the measurement sequence and collects the data, uploading it to the Control Centre at DNV GL for interpretation, via a GPRS communication card. The system was then left unattended for the duration of the trial, and EDP Distribuição were given access to a secure web site where we could follow up on any PD activity and risk values in the circuits assessed.

The **HVPD Ltd (High Voltage Partial Discharge)** solution adopted by EDP Distribuição was the appliance of the first 3 phases of the HVPD’s 4-phase asset management, designed to detect, locate, diagnose and monitor PD activity in the MV electrical grid.

The first phase, the “PD Surveying Stage”, is a survey to detect PD Activity and it is performed using a simple screening device (the “HVPD-PDS AirTM”). This small portable device includes three PD sensors: a transient earth voltage (TEV) sensor to detect local electromagnetic activity inside metal clad plant switchgear; an airborne acoustic (AA) sensor for detection of discharges into air and an external sensor, the HFCT (High Frequency Current Transformer) sensor, to detect PD activity in cables by attaching it to the earth connections of in-service MV (or HV) cables.

The second phase is the “PD Diagnostics and Location Stage” in which the HVPD-LongshotTM Unit is used. This portable test device is suitable for short duration on-line PD testing. It uses the same sensors used in phase 1 whilst also recording data from four channels. The software included provides automatic PD activity diagnosis. Mapping techniques are then used to locate the PD activity along the cable, when present.

The third phase is the “Short Term Monitoring of PD Trends” which is achieved using the HVPD MultiTM and MiniTM monitors to detect and analyse continuously the PD activity in several circuits at the same time through multiple channels (4 in the Mini-MonitorTM and 16 in the Multi-MonitorTM) grading the PD activity in each channel in a colour scale according to the level of the PD activity. The Mini-MonitorTM is designed for RMU or secondary substations and the Multi-MonitorTM is used mainly for primary larger substations. Through these monitors it is possible to determine (using HFCT sensors) the existence of PD and also, through a statistical algorithm that determines the direction of the discharges, the PD sources (cable or substation switchgear).

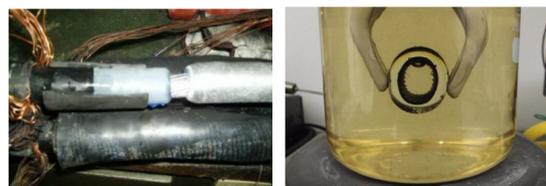
The laboratory test on cables consists in cutting a small portion of the cable (around 5cm) in a helical shape, so every portion is 0.6/0.7 mm thick. This portion is then immersed in glycerine at 130°C and the whole set is backlit to observe contaminants or damages to the insulation (as shown in Figure 4). When such problems are detected, the portion is thoroughly inspected.

The joints, on the other hand, are fully opened and traces of water, dirtiness and signs of poor execution are screened (Figure 4).

Figure 4 – Joint analysis (left) and cable insulation diagnosis (right).

The result of the full diagnosis of the cable/joint indicates not only the presence of the contaminants in the insulation but it also defines, according to a risk matrix, the severity of the condition of the cable and, consequently, the priority to replace the cable. This information is useful to plan the investment according to real data.
