## DEGRADATION CHARACTERISTICS OF THE POLYPROPYLENE-INSULATED CABLES AND JOINTS AT EMERGENCY OVERLOAD

### ABSTRACT

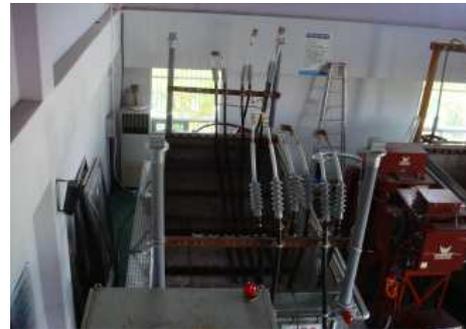
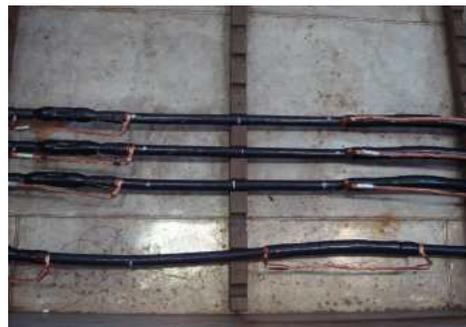
Fig. 1 Experiment Setup

Polypropylene-insulated cables are connected to the conventional joints and terminations (Fig. 1). Joints are two types that one is pre-molded, the other is cold shrink. The first step is a conductor temperature of 130 degrees,

(a) Experiment setup

(b) Joints

a holding time of 72 hours. The second step is a conductor temperature of 140 degrees, a holding time of 72 hours. Finally the third step is a conductor temperature of 150, a holding time of 72 hours. This test simulated the worst conditions.

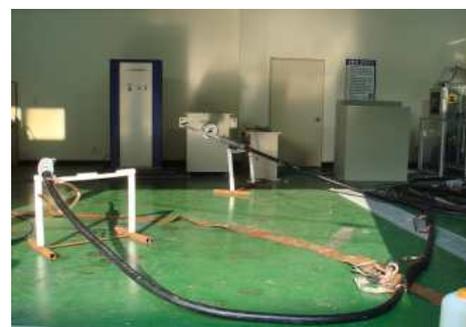
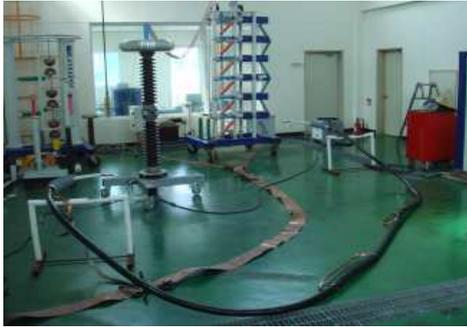
(b) Impulse test  
Fig. 2 Electrical performance test

The sample from each step was carried out for the electrical performance test such as voltage withstand test and impulse voltage test (Fig. 2)[3].

(a) Voltage withstand test

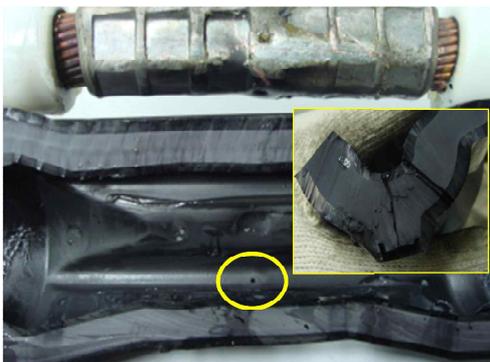
Fig. 3 part of break down

The results of electrical performance test are as follows in Table 1. Despite the severe test conditions, all three samples exhibited good characteristics. The breakdown of the joints is made of manufacturing defect.

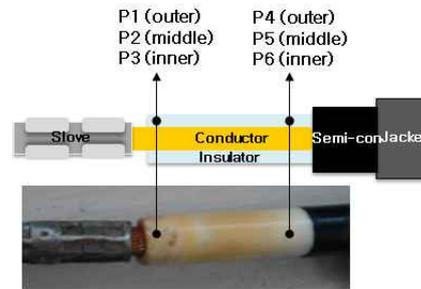
Fig. 4 test points

New		#1 Pre-Molded	#3 Pre-Molded	#3 Cold Shrink
N-P1	Discoloration P1~3			
	Non-Discoloration P4~6

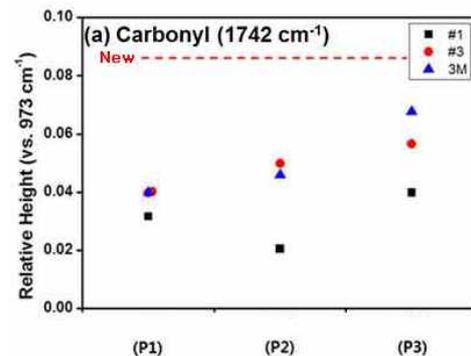
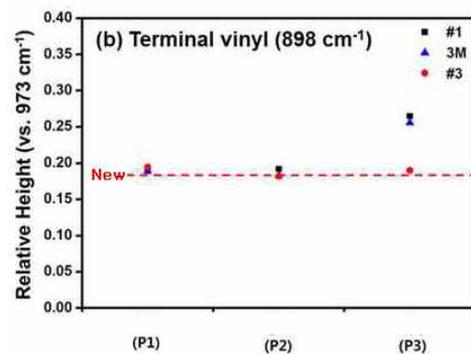
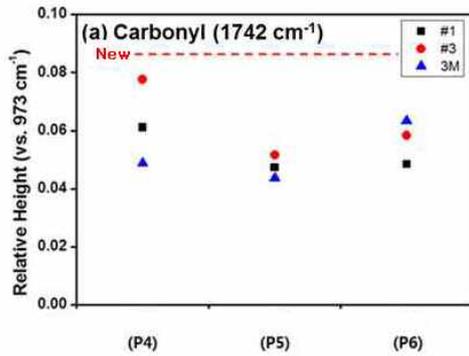
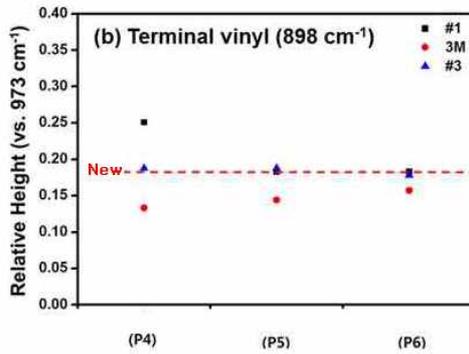
(b) P4~P6  
Fig. 5 Results of FTIR

when break down. The sample except the #1 pre-molded can be seen the fact that degradation proceeds as compared to the new one. In accordance with the progress of degradation, carbonyl peak ( $1742\text{cm}^{-1}$ ) is decreased as the antioxidant is consumed and terminal vinyl peak ( $898\text{cm}^{-1}$ ) is increased. OIT of discoloration part (P1~P3) is decreased as compared to the new one.

(a) P1~P3

We performed additional test about polypropylene insulation of #1pre-molded, #3 pre-molded, #3 cold shrink. Test methods are FTIR, DSC-OIT. The results are shown as Fig. 5 and Fig. 6. Sample of #1 should be excluded from analysis because the part is carbonized

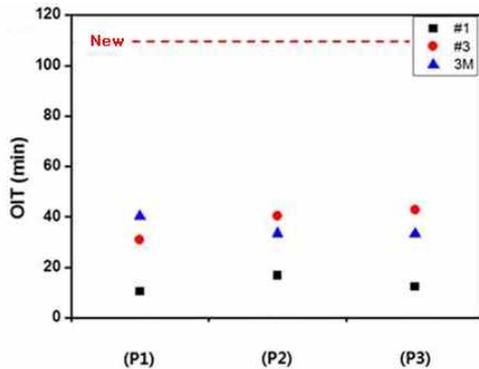
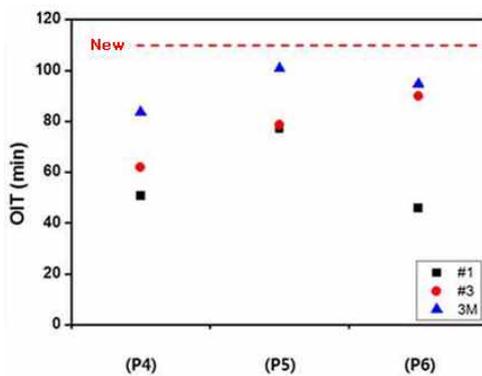
(b) P4~P6  
Fig. 6 Results of DSC-OIT

(a) P1~P3

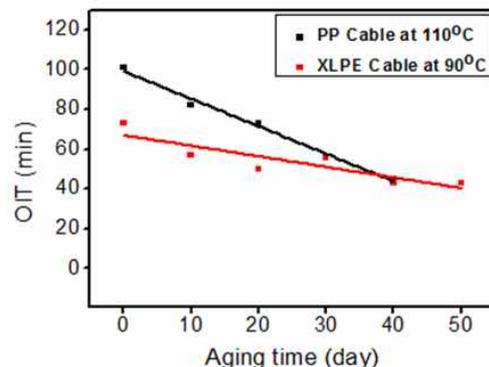
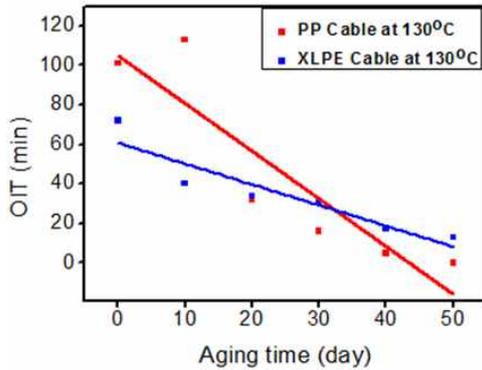
Fig. 7 Results of DSC-OIT

The results of thermal aging test are interesting. DSC-OIT results with aging time, the initial oxidation induction time is excellent, but the slope is greater decrease due to degradation after 30 day (Fig. 7). FTIR results show that the degradation has progressed. That is, the decrease of carbonyl peak and the increase of terminal vinyl mean the degradation of insulation (Fig. 8). The results of mechanical performance test, the tensile strength of PP, XLPE was no change, but elongation of Polypropylene was a little lower than XLPE's (Fig. 9).
