SELF-HEALING MATERIALS FOR AUTONOMOUS CABLE REPAIR

ABSTRACT

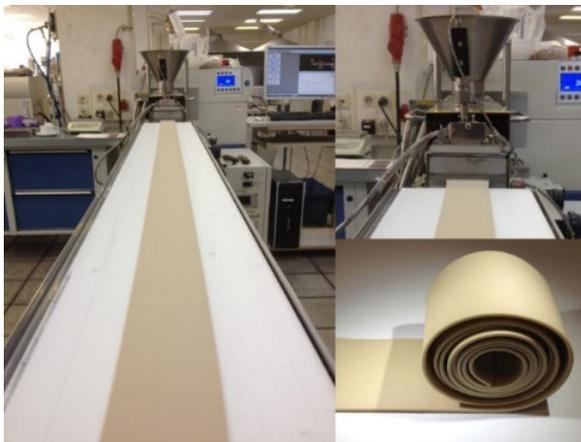
Figure 11. Extrusion of h-TPE ribbon

With regards to the processing of these materials, it has been found that extrudable h-TPEs possess excellent compatibility with common cable manufacturing processes, and can be extruded at speeds commensurate with cable extrusion without evidence of damage or reduction in performance (see **Figure 11**). This contrasts with WBTs, which require expensive and complicated tape-winding machinery in order to be incorporated into the cable structure, resulting in slow production rates.

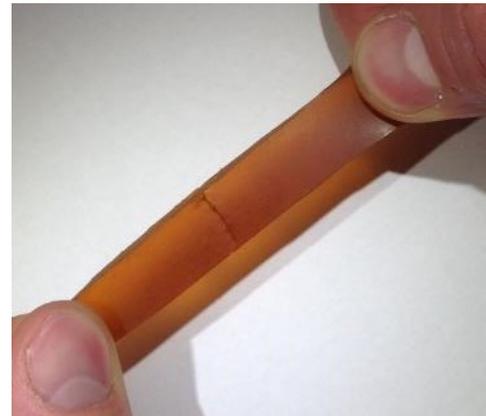
Figure 12. Sample of intrinsic self-repair material after bisection and re-joining. After 24 hours, the damaged region demonstrated excellent strength and could not be separated by physical force.

From these results, it can be concluded that extrudable h-TPEs have significant potential to displace WBTs within cable structures. While this may be considered a form of ‘asset self-repair’, however, it is not true materials self-repair, it is a material response resulting in self-repair. Gnosys is currently carrying out investigations into the use of ‘intrinsic’ self-healing materials, which can permanently heal if rejoined after damage (see **Figure 12**). If combined with an h-TPE system (either as a blend or as a synergistic bilayer) it may be possible to develop a self-repair layer that firstly swells in response to the presence of water, and then forms a permanent repair of both the material and the cable.
