TEARDOWN OF A COMPACT DISTRIBUTION TRANSFORMER AFTER TWELVE YEARS OF SEVERE LOADING CONDITIONS

ABSTRACT

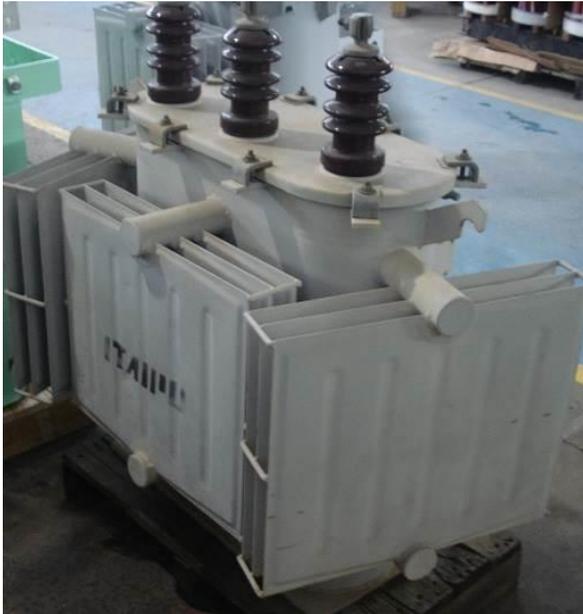
Figure 1 shows the transformer as removed from the pole, after 12 years of continuous loading. It can be seen the wearing of the painting, but no signals of any leakage.

Figure 1. Overview of the prototype transformer after 12 years of continuous service at overhead distribution lines in Brazil.

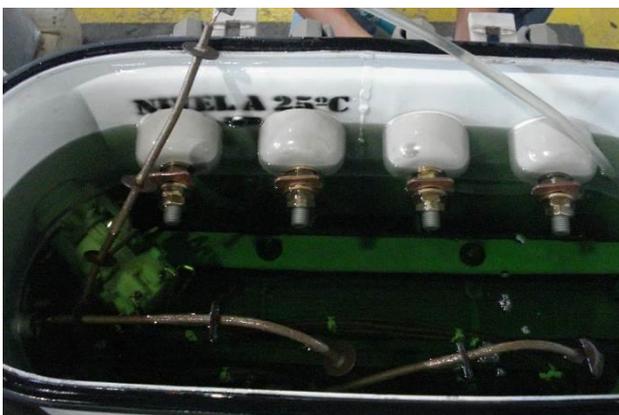
Figure 2 shows the inside of the transformer at the time of cover removal. As typical in distribution transformers in Brazil, the transformer has a headspace for absorbing the volumetric expansion of the dielectric liquid due to temperature variation. This headspace is not filled with any inert gas, it was ambient air when the transformer was closed, kept confined along the years.

The natural ester liquid is clean and transparent, still holding its original green colour.

No film is seen on top of the liquid nor on the tank walls or internal portions of the bushings. It is also remarkable the absence of any indication of corrosion commonly seen when removing the cover of distribution transformers. The dry-out effect of natural ester, responsible by keeping the insulating paper dry, has also kept the air cushion free of moisture, preventing the formation of corrosion spots. No visible signs of degradation can be identified to the transformer or its

Figure 2. Transformer after cover removal.

components in this top view.

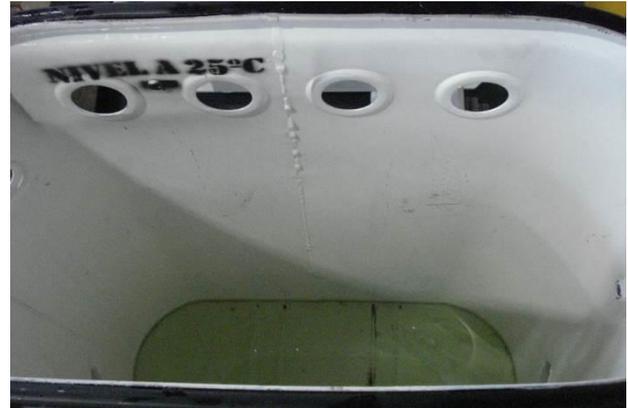
Figure 3. View of tank bottom, after removal of active parts and fluid.

Fig. 3 shows the internal part of the tank after removal of core and coils and drained of dielectric liquid. At the bottom a small volume of natural ester may be identified, as the draining was performed by a suction system (no drain valve available). Also remarkable is the absence of sludge at the bottom. A mineral oil transformer loaded similarly would be expected to have a relevant amount of solid material at tank bottom. The absence of any type of wax or gel at tank bottom also confirms the oxidation stability natural ester liquid.

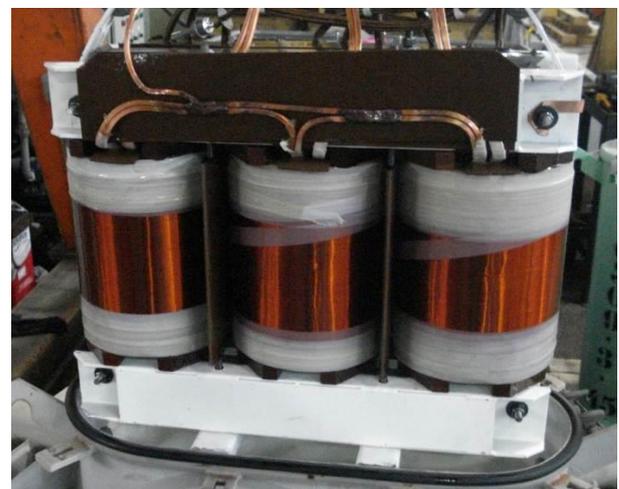
Figure 4 shows the core/coil assembly, having the appearance of a brand new unit.

Figure 4. Core and coil assembly immediately after unloading

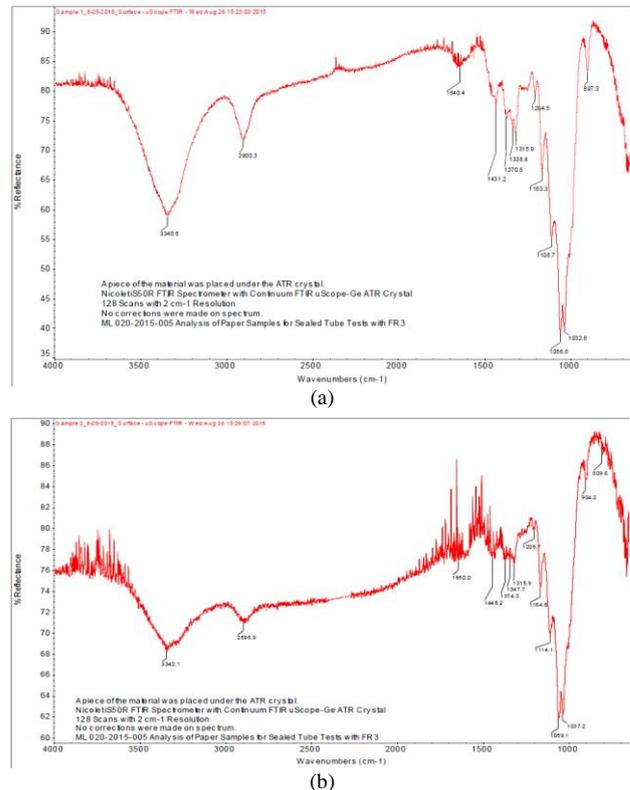
This trend of increasing acid number and dissipation factor has also been seen in several power transformers where natural ester liquid was applied, always increasing at a very low rate. The production of acids is driven by the water extracted from the cellulosic materials, both the residual after the oven drying and the generated by the paper ageing. The acid number of the new fluid was 0.03 mg KOH/g, increasing to 0.174 in 12 years – an increase of 0.012 mg KOH/g per year. For a distribution transformer life expectancy of 25 years, the value at the end of life would be 0.33 mg KOH/g, very close to the suggested limit of continuous operation of standards [12]. It was also a target of this investigation to search for evidences of transesterification. The main indication of the process would be a modification in the structure of the Kraft paper, indicated by the appearance of a weak band at the 1717cm⁻¹. However, this carbonyl band has not been identified in the FTIR results.

All 6 paper samples were extracted for approximately 4 hours in a soxhlet extractor with a 10% acetone in heptane solvent to remove all traces of the dielectric fluid. The FTIR spectra of all samples were very similar. Representative spectra are shown in Fig. 5.

The non-identification of the transesterified cellulose does not mean the hypothesis is not valid. The high values of DP of the paper shows the process of degradation was still at the beginning, in comparison to the accelerated aging tests performed with the sealed vessels. Apparently the process was not long enough to reach a significant level of transesterification.

Figure 5. FTIR spectra: (a) sample 5, average measured value of residual DP; (b) sample 3, lowest measured DP
