VIRTUAL ASSESSMENT WITHIN 24 HOURS OF A DISASTER

ABSTRACT

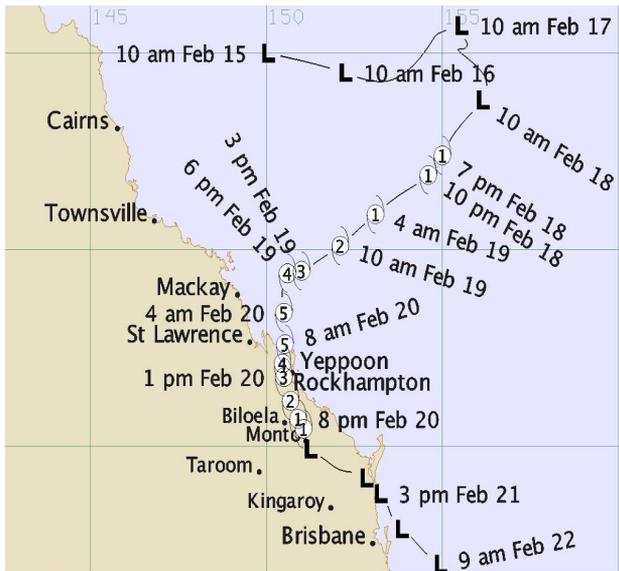
Figure 1: Track of Tropical Cyclone Marcia

Severe tropical cyclone (TC) Marcia made landfall as a category 5 cyclone at 8am Friday 20th February 2015 at Shoalwater Bay, North of Yeppoon, Queensland. The cyclone then weakened steadily as it moved Southward over land during the day. The town of Yeppoon received significant damage, and wind gusts up to 156 km/h were recorded there as the cyclone passed to the west. A storm surge of 2 metres was recorded at Port Alma, but luckily this occurred near low tide.

The weakening cyclone passed over Rockhampton during the early afternoon of Friday 20th February 2015, where wind gusts up to 113 km/h were recorded and again significant damage occurred. Marcia then turned to the south-southeast and impacted the town of Biloela early that evening, where wind gusts to 85 km/h were recorded. Marcia was finally downgraded to a tropical low at 2am on Saturday, February 21st 2015.

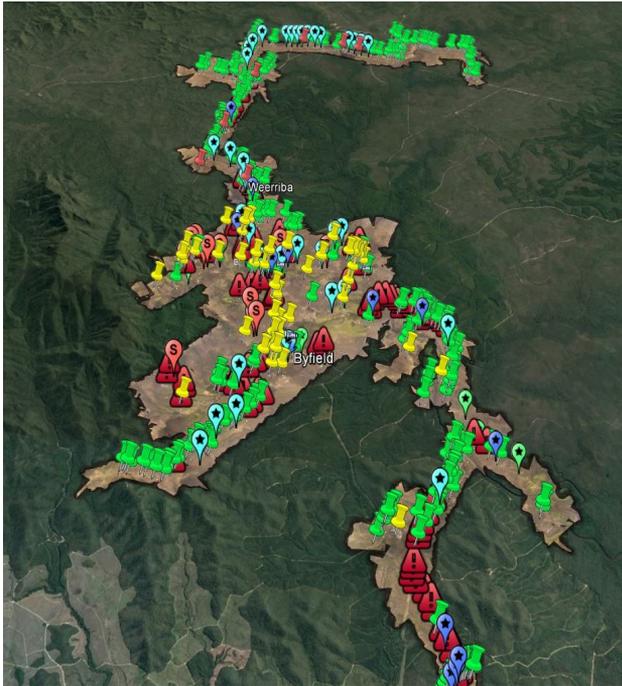
Figure 2: Overview of the Byfield area with storm damaged assets highlighted

Automated algorithms assessed the network and its surroundings and provided a report of the effects on the overhead network.

- Fallen Powerlines - 393
- Low Conductor - 189
- Fallen Pole - 28
- Debris/vegetation on powerline - 44
- Damaged building - 479
- Debris across road - 607
- Damaged Road - 41

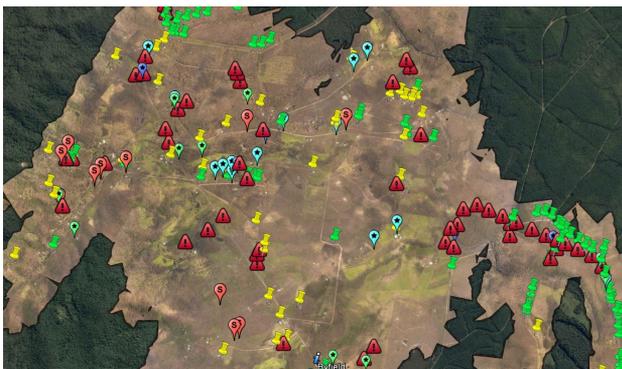
Figure 3: More detailed view of Byfield area with storm damaged assets highlighted

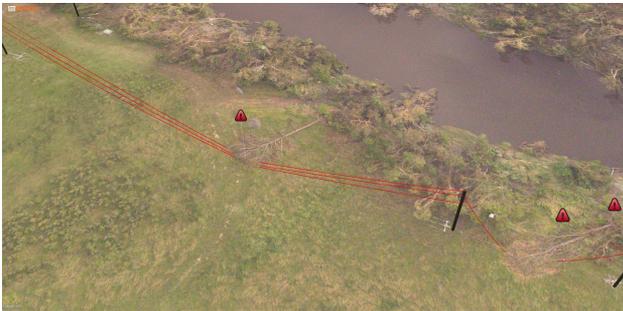
Figure 4: Roames imagery & 3D network highlighting downed trees on the network

Both the Roames 3D network model and imagery layers

were invaluable in the process of identifying potential risks prior to dispatching of crews.

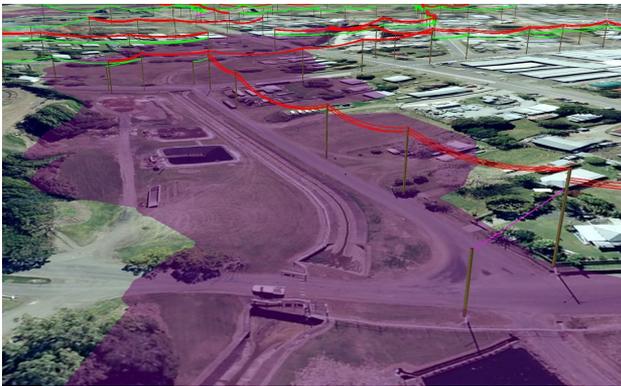
Figure 5: Roames 3D Network model and 2010 Flood extents in Bundaberg, Queensland

Three-quarters of the council areas within the state of Queensland were declared disaster zones. One such council was Bundaberg. Fugro were tasked by the council to acquire data to populate the Roames VWAM system. These analytics were used to identify the parts of the OHL network that were cut off by the rising flood waters and report any damage on the network.

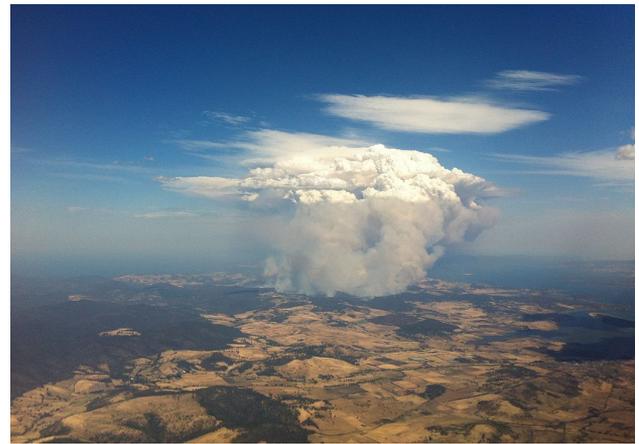
Figure 6: Aerial View of bushfire at Copping/Forcett

the Australian Federal and State Governments Fugro were instructed to mobilise and prepare their VWAM system. Roames was used to rapidly identify the damaged and destroyed OHL network and the information gathered was used as part of the emergency services response programme.
