ANALYSIS OF RUSTY CLOSED TYPE SWITCHGEARS

Kazuki MORII

The Kansai Electric Power Co., Inc. - Japan

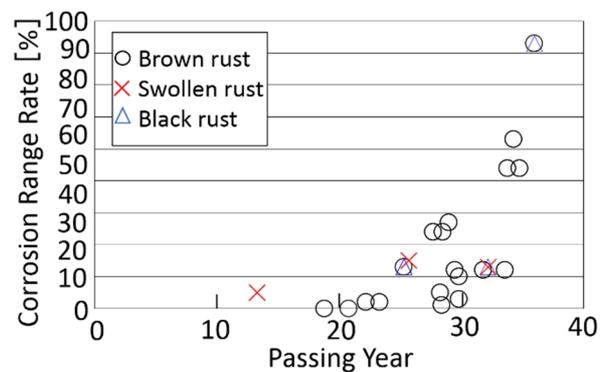
Fig.8: Corrosion Range Rate across Passing Years

It is generally thought that corrosion range increases in proportion to SW's age. In the largest case, 80% of the surface are rusted, which was 35 years old. On the other hand, there are SWs that rarely rust even 25 years after installation. The strong relevance is not observed between the passing years and corrosion range rate.

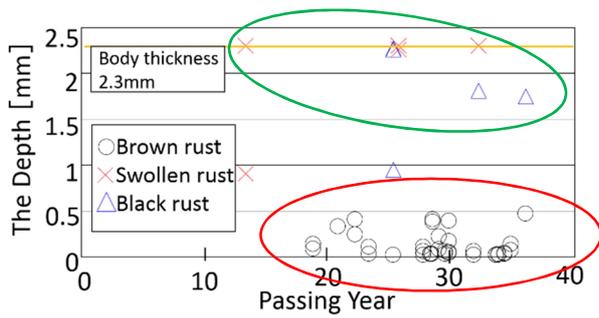
Fig.9: Depth of Rust across Passing Years

We examined relevance between the depth of corrosion and outlook of rust such as area and color. Black rust is much worse than brown rust. In addition, swollen rust is confirmed as bad as black rust, corrosion by swollen rust reaches almost as same depth as black rust. (Fig.9, 10)

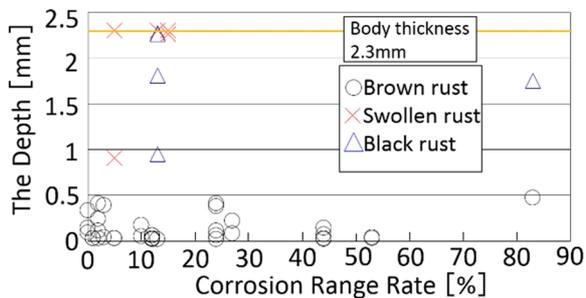
Fig.11: Depth of Rust and Corrosion Rate

Fig.11 shows the relevance between depth of rust and corrosion range rate. The amount of rust range is not clearly related to the depth.

As a result of the examination, we found that the depth of rust has correlation with not the corrosion range but the color of rust (rust condition).

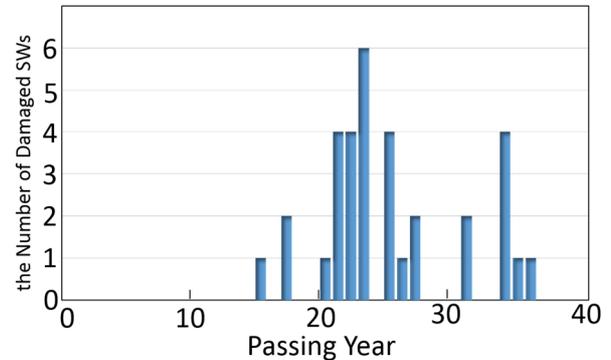
Fig.12: the Number of Dissimilar Metal Corrosion with Aluminum

As mentioned above, some SWs have aluminum housing because aluminum is more resistant to rust than iron. However, stainless steel bolts are used for this type of SW; Dissimilar metal corrosion have occurred between stainless and aluminum due to ionization tendency difference.

Fig.12 shows the number of switchgears that failed airtightness due to dissimilar metal corrosion by SW age. Dissimilar metal corrosion may occur as early as 15 years after installation.

Accordingly, we have reflected this knowledge in our new specification of SW; the stainless steel housing and stainless steel bolts are adopted in the current type SW.
