## CHOICE OF MV FEEDER BIL TO MAXIMIZE QOS AND MINIMIZE EQUIPMENT FAILURE

### ABSTRACT

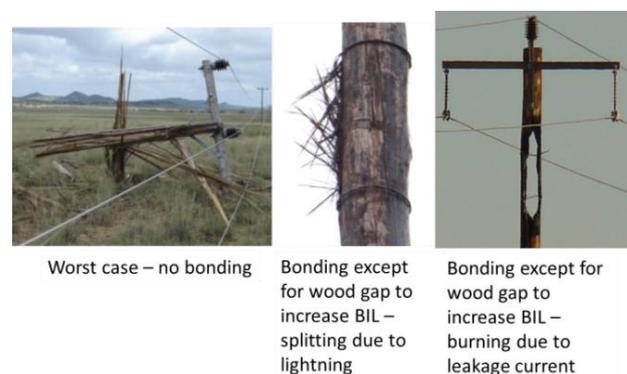
Figure 2. Wood damage due to lightning and leakage currents

In some Eskom MV networks, up to 78% of equipment failures have been attributed to lightning. In the case of MV feeders, the insulation to earth typically consists of a 150 kV Basic Insulation Level (BIL) insulator in series with a 150 kV BIL wood gap on the bonded wood-pole [1] as shown in Figure 1. The wood also provides some power frequency arc quenching properties [2]. The 300 kV BIL philosophy was implemented to ensure that no indirect lightning strikes caused a phase-to-earth flashover. Unfortunately, the higher the BIL, the higher the amplitude of the voltage and current lightning surges on the feeders and this causes fuse, surge arrester and transformer failures during lightning storms. Direct strikes will cause a flashover across the wood gap and this will very often split the wood as shown in Figure 2.

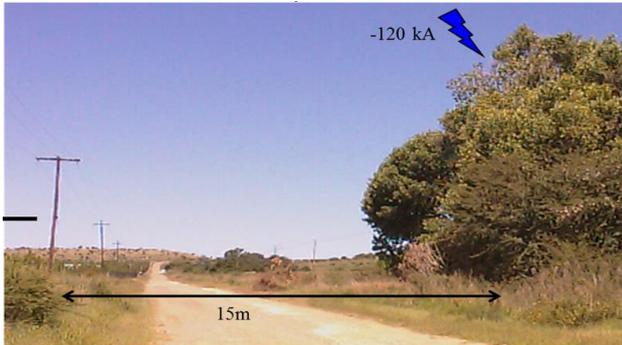
Figure 6. A -120 kA strike terminated 15 m from the feeder.

A particular case where a negative 120 kA strike terminated 15 m from the feeder (Figure 6) where the BIL was 180 kV was analysed. The induced voltage can be calculated as:

$$Um = \left( 1 + \frac{10^8/3 \cdot 10^8}{\sqrt{2-(10^8/3 \cdot 10^8)^2}} \right) \left( \frac{10 \cdot 120}{15} \right) = 2.98 \text{ MV}$$

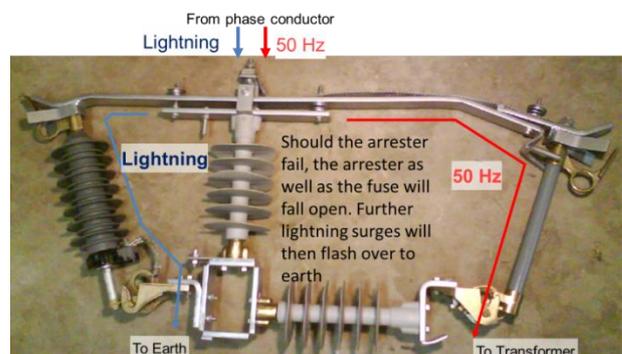
Figure 8. The Combi unit to protect the transformer and fuse after surge arrester failure.

A Combi unit was designed. A failed arrester drops out and then the fuse opens as well. Subsequent strikes will flash over to earth while in the process of replacing the broken arrester. Both transformer and fuse are therefore protected against lightning. Fuse grading challenges with protection were also addressed. Both the arrester and the fuse can be replaced safely from ground level.
